# **Hydrological field research factsheet – Gromovo Fluviogeneus Mire – Kaliningrad Region, Russia**

Technical report of the DESIRE project – action 3.2

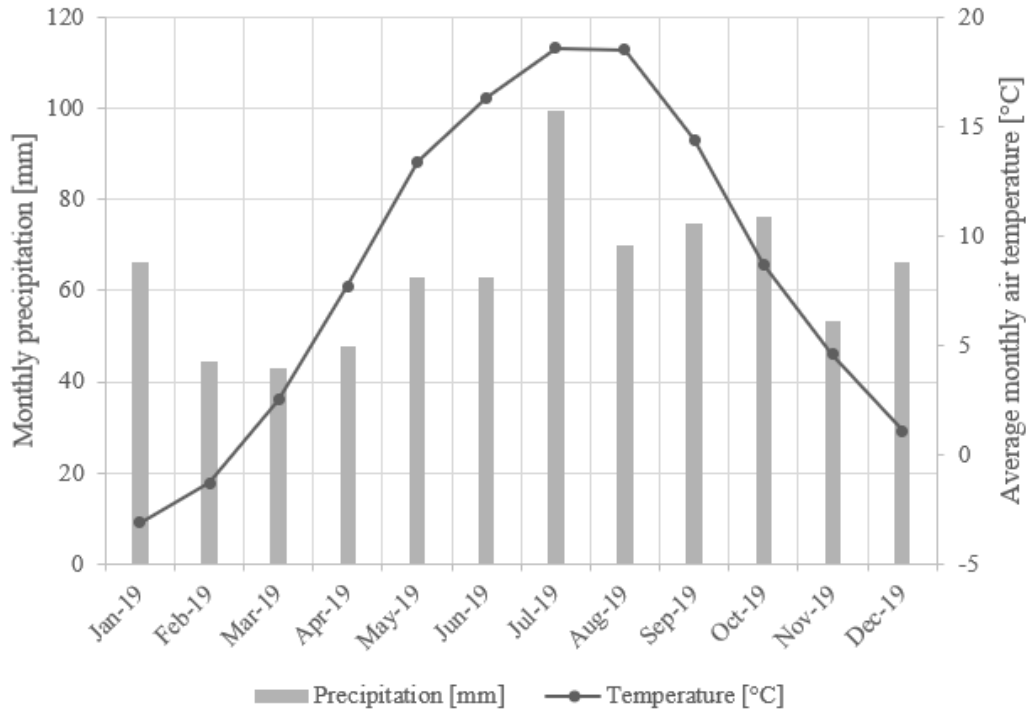
**Figure 4.** Summary of monthly precipitation in millimeters and monthly average air temperature in °C in Gromovo in 2019.

Based on the 2019 meteorological data from Gromovo village, the coldest month was January with the average monthly air temperature equaled  $-3.1^{\circ}\text{C}$ , and the warmest was July with the temperature of  $18.6^{\circ}\text{C}$ . The driest month was March (42.9 mm) and the wettest month was July with 99.6 mm. The annual precipitation was 766.9 mm. The summary of monthly precipitation and average monthly air temperature in Gromovo in 2019 is shown in Figure 4.

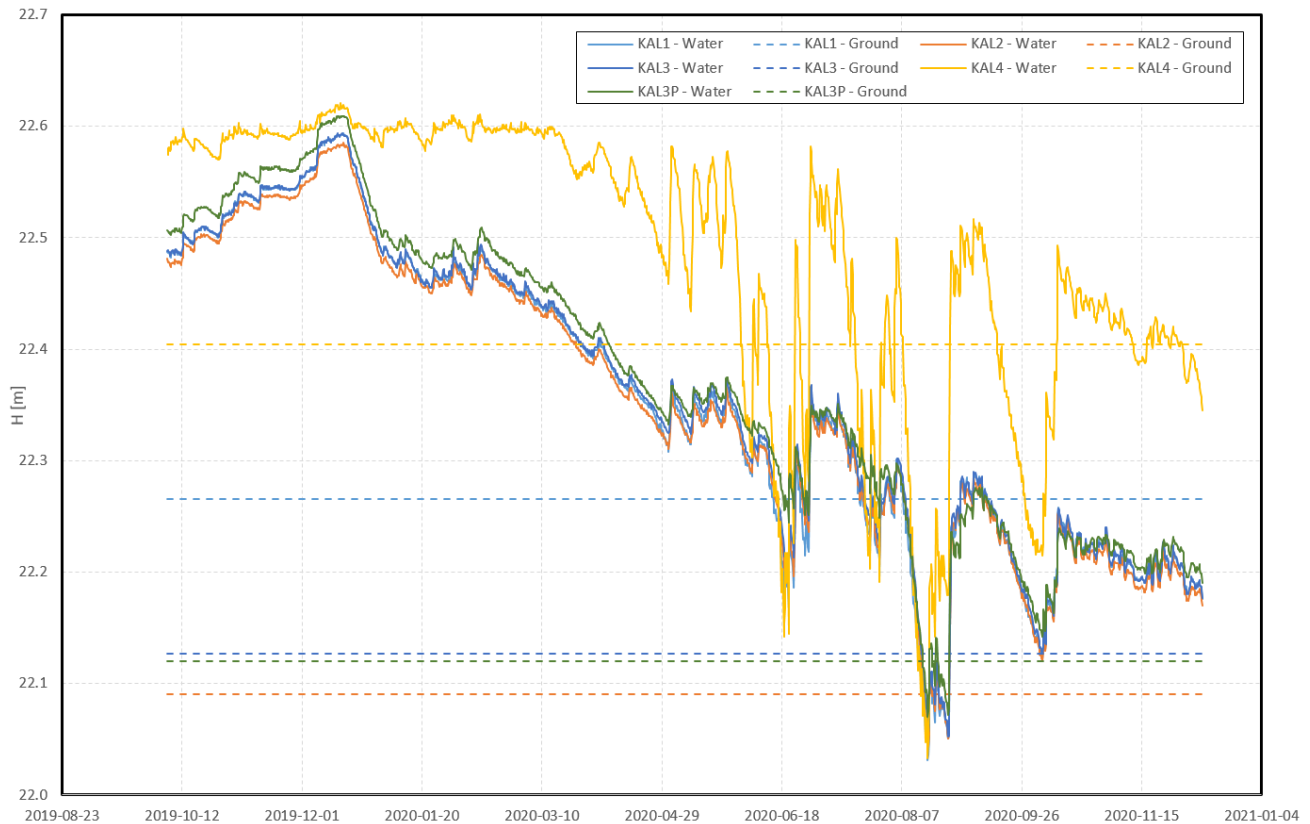
**Figure 6.** Variability of the groundwater table in the piezometers on the Gromovo Fluviogeneous Mire.

Water table in the whole mire is constantly above ground level, even in the higher parts of the area. In the measurement period for 3 piezometers (KAL2, KAL3, KAL3P) the water table was above the ground level almost all the time. It is unique for this type of peatlands in this part of the world, additionally taking into account the attempt of its reclamation. It can be concluded that the height of the water table was dependent on atmospheric conditions during the study period, however, these changes did not affect the overall condition of the studied peatland (continuous water saturation). Figure 6 shows the variation of water table in time for individual piezometers and the statistics are contained in the Table 2.

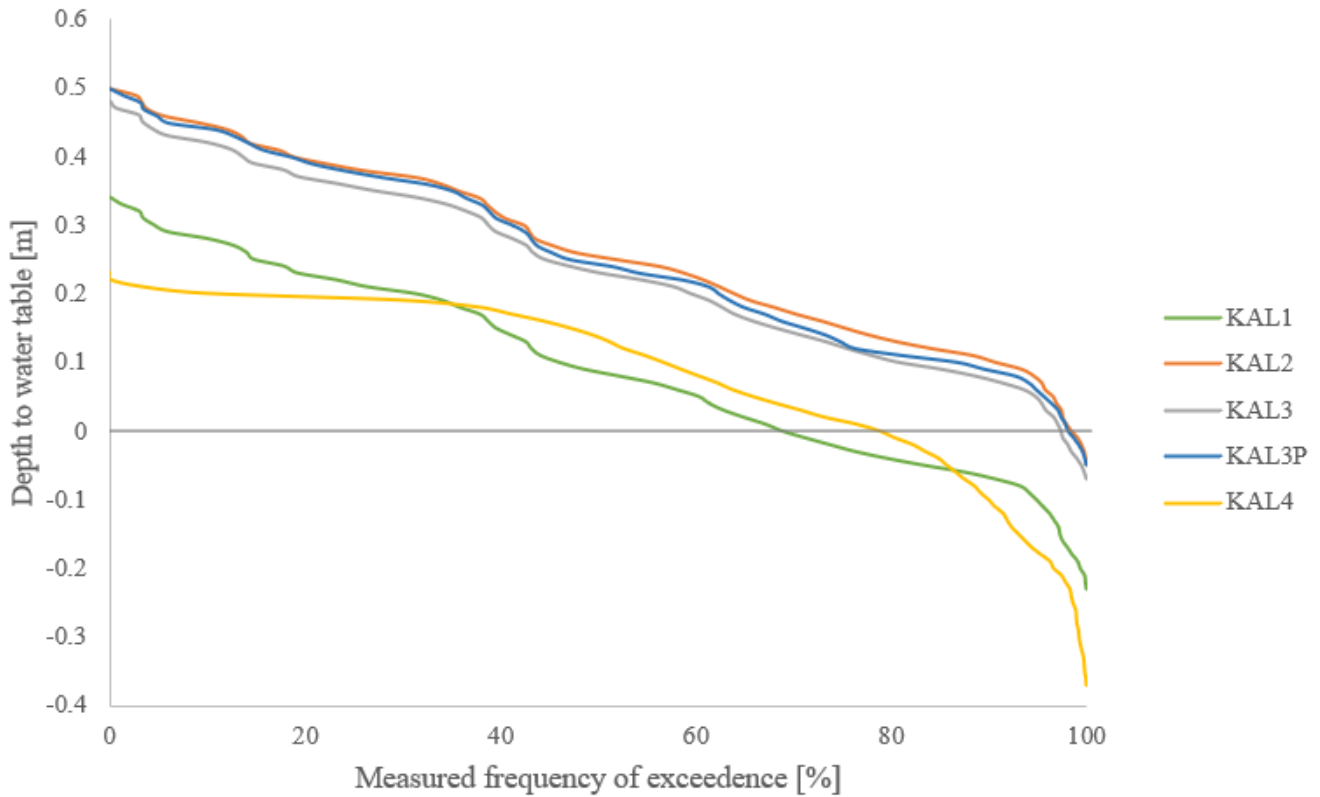
Figure 7 shows water-level-duration curves for 5 piezometers located in the Gromovo Fluviogeneous Mire. Axis X represents measured frequency of exceedance where depth to the water table is higher or equal to value from axis Y.

**Figure 7.** Water-level-duration curves for 5 piezometers located in the Gromovo Fluviogeneous Mire.

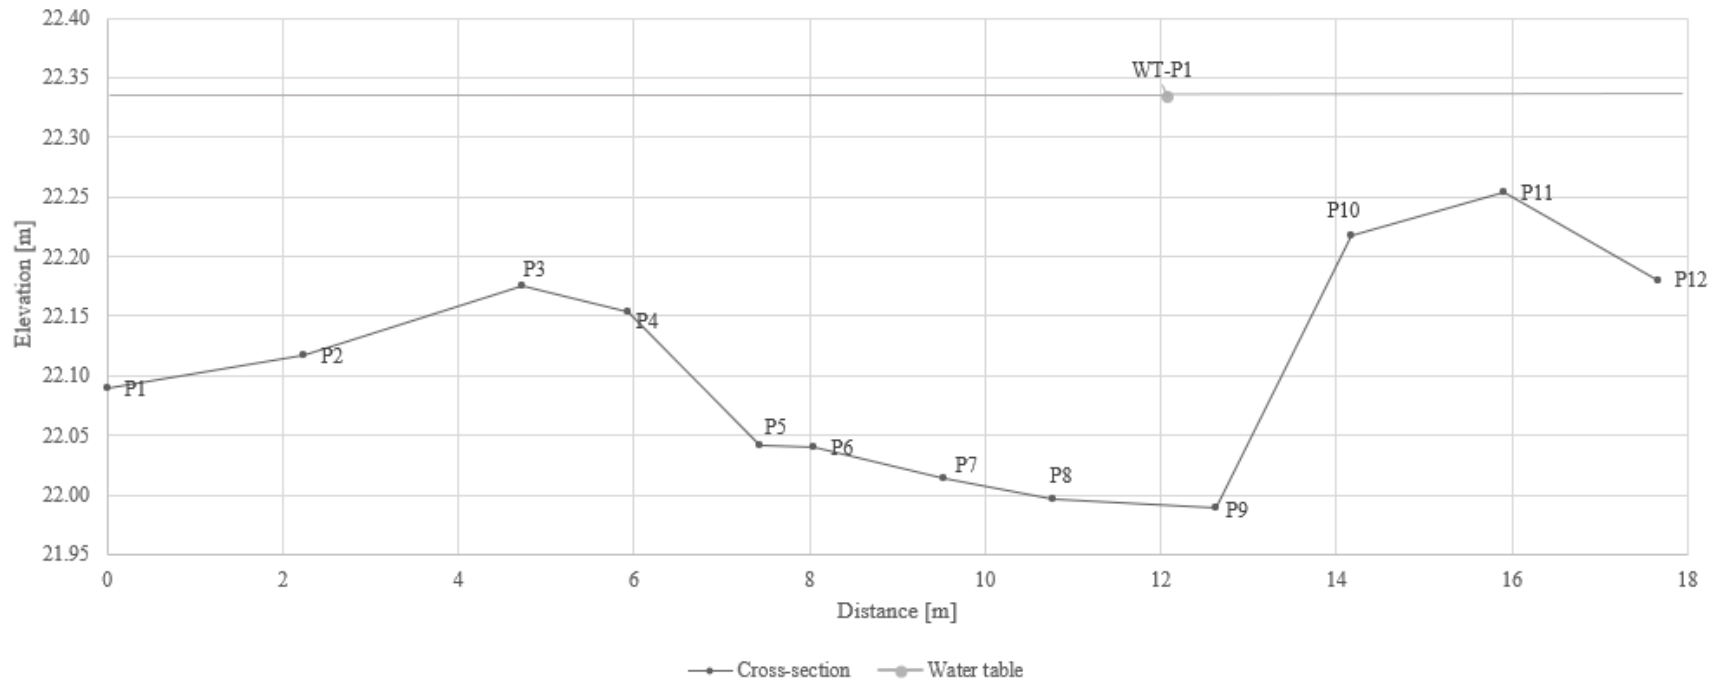
### Annex 1. Cross section of a drainage ditch located in the Gromovo Fluviogeneous Mire.
